## Upgrade SOP for Solis Inverter Compliance to AS/NZS 4777.2:2020

### 1. Scope

From 18th Dec 2021, all newly installed inverters in Australia need to comply with AS/NZS 4777.2:2020 standard and have grid code parameters set per Australia A/B/C requirements during commissioning.

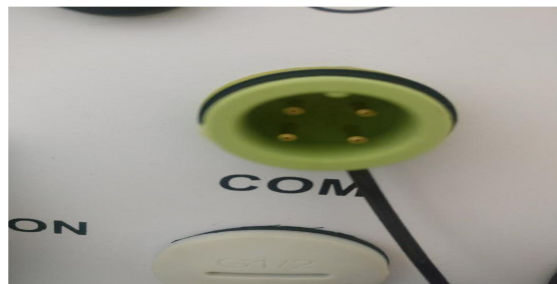
**Step 2.** Connect the Solis Wi-Fi dongle to the inverter 4pin round COM port
