# SUMMITVILLE, COLORADO

## HIGH SULFIDATION SYSTEM

### CLASSIC ZONING

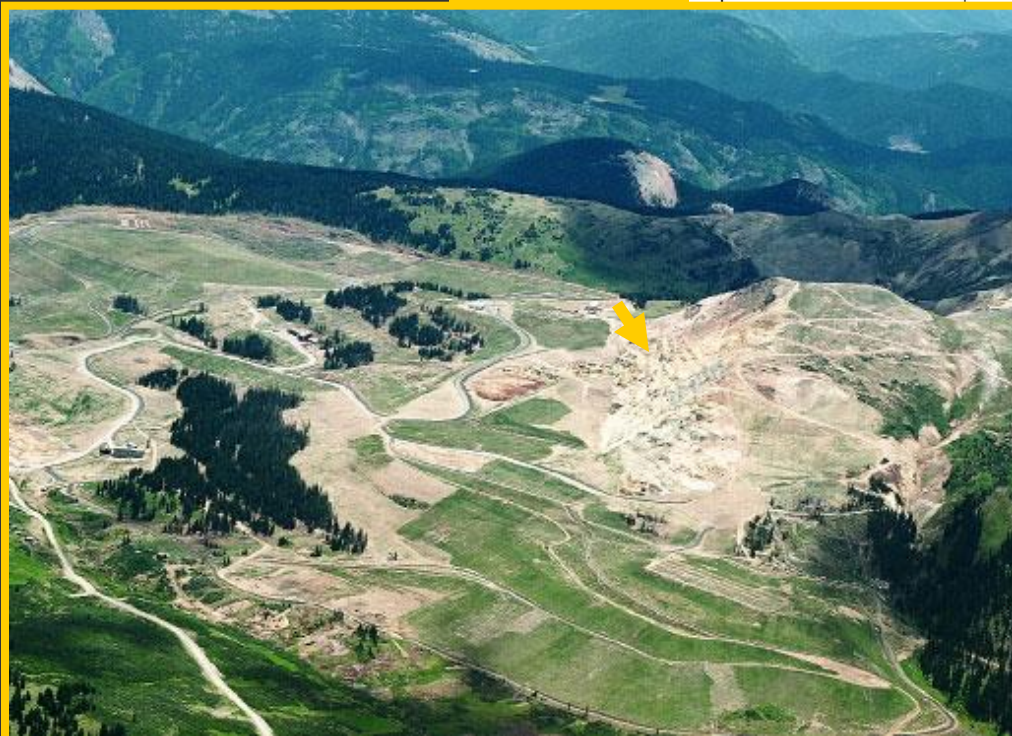
The intense acid leaching that occurred at Summitville produced a distinctive advanced argillic alteration suite. This figure summarizes the alteration envelopes seen consistently in the mine illustrating the progressively less acid environment that develops away from the veins. (Modified from Stoffregen, 1987)
